**DAM INSPECTION CHECKLIST
POSSUM POINT POWER STATION
POND ABC**

INSPECTION DATE: 5/26/15

INSPECTED BY: D. West, K. Homza

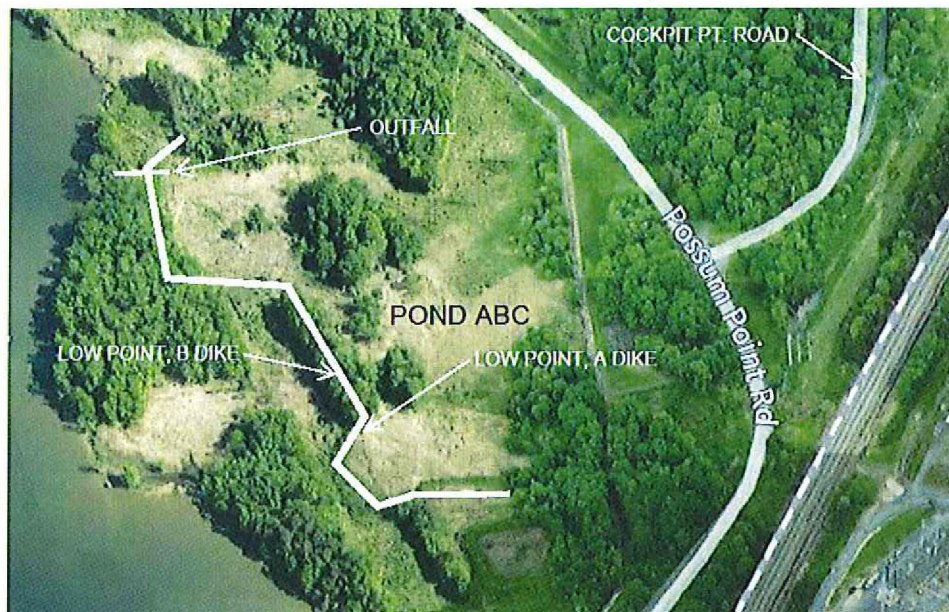
* See figure below.

Location/ Condition	(y/n)	Change (y/n)	Comments
Low Point, A dike*			
Flow	N	N	1045 hrs. Standing water behind sandbags, and along perimeter of pond near road. Sandbags and rip rap in place.
Erosion	N	N	
Low Point, B dike*			
Flow	N	N	1047 hrs. No standing water. Sand bags and rip rap in place.
Erosion	N	N	
Outfall			
water surface El. (top of stoplogs to water)			1053 hrs. Standing water behind sand bags and concrete weir structure. Small amount of dripping at weir in the corners. Does not appear to be ^{flow at} discharge pipe. 49"
